# CAMERON OFFICES – WING 3 AND THE BRIDGE HERITAGE MANAGEMENT PLAN

ISSUE 8  
22089  
25 March 2024

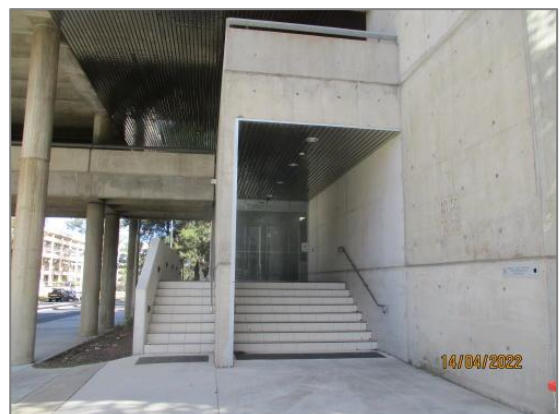
- Ramp added externally to improve access for people with disabilities into the building.
- Entry stairs have been upgraded with handrails, tactile ground surface indicators (TGSI) and contrast nosing.

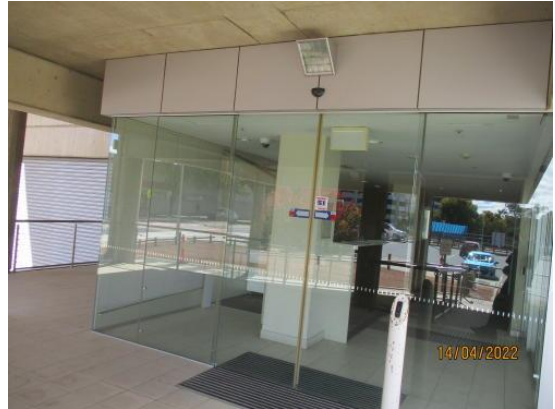
- Fitout to core
  - Core and entry area includes full height glazing in clear anodized frames with aluminum panels above.
  - Floor is tile with ribbed rubber mats at entrances.

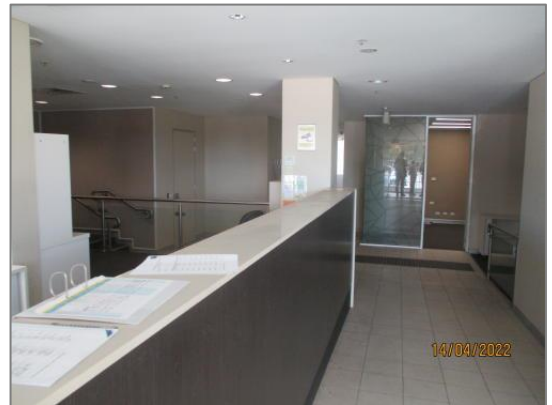
- Ceiling is a flat sheet with recessed downlights generally although half the bridge has an exposed precast structural T-beam.
- Walls are generally rendered and painted.
- Reception desk has been added.

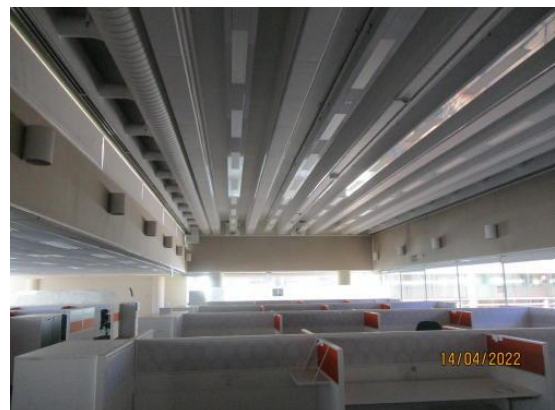
- Wings
  - Fitout to the wings is largely open retaining a full appreciation of the structural system which is painted white.
  - There are some offices with painted plasterboard walls, suspended ceilings clear anodized aluminium framed glass partitions and mini venetian blinds.
  - Doors are generally solid and painted.

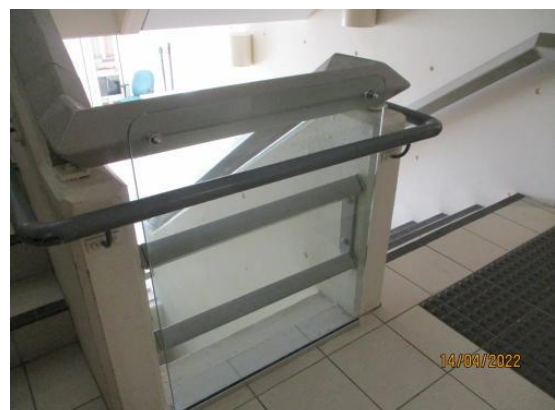
- Stairs
  - Stairs between floors and the split levels are tiled.
  - There is a large 100mm x 100mm handrail which has been supplement with a 50mm diameter galvanized handrail which is more usable.

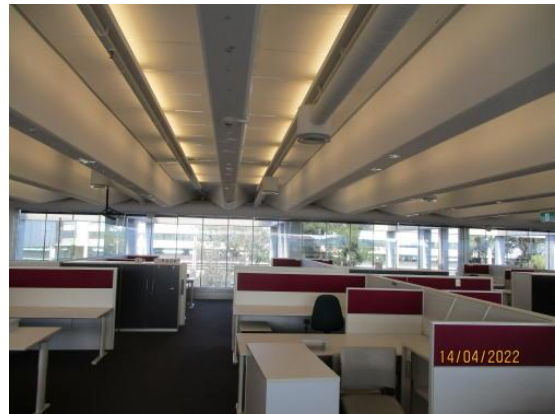
- Ceilings
  - These are exposed precast and beams painted white with mechanical ducts exposed along the north side and with lights and sprinklers in between.

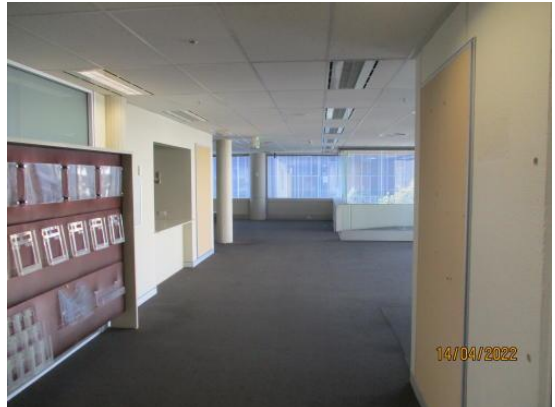
- Floor
  - The floor is carpeted throughout.

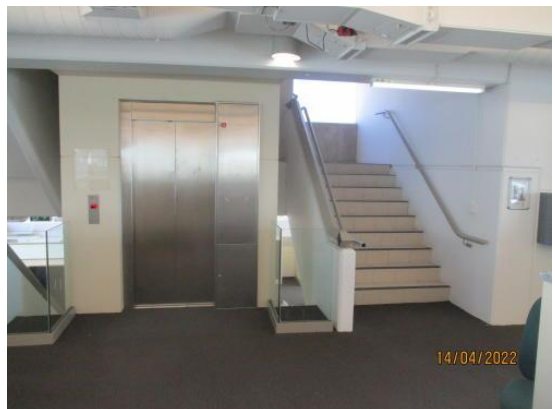
- Lift
  - The split-level link includes a lift which is a later addition.

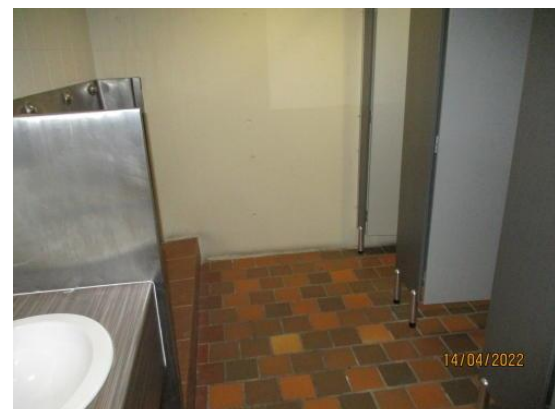
- Toilets
  - The toilets have largely been refurbished with some alteration to include accessible facilities.

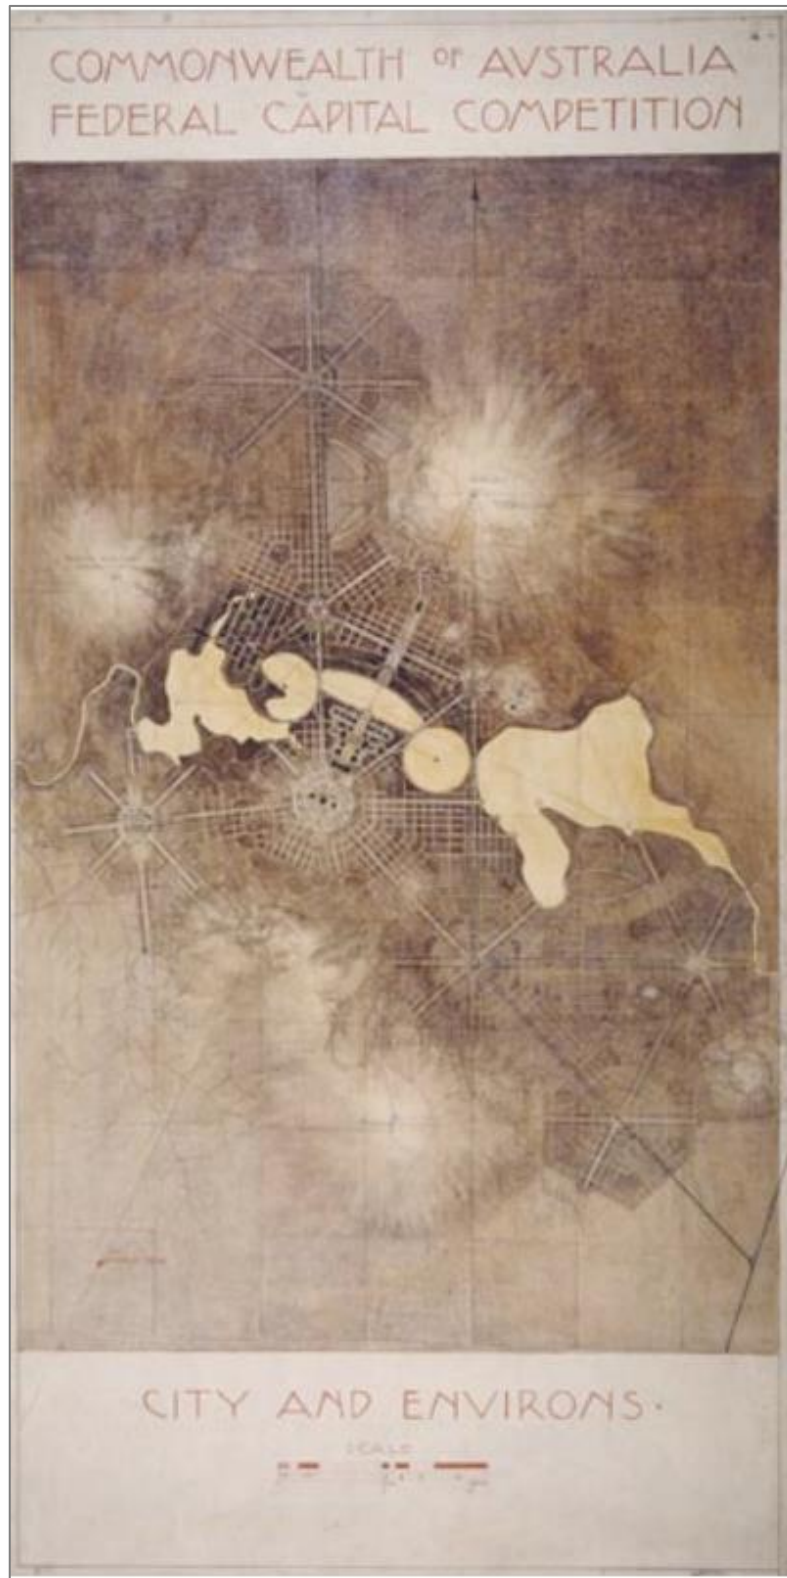
**Figure 41: Griffin's 1912 Competition Plan**

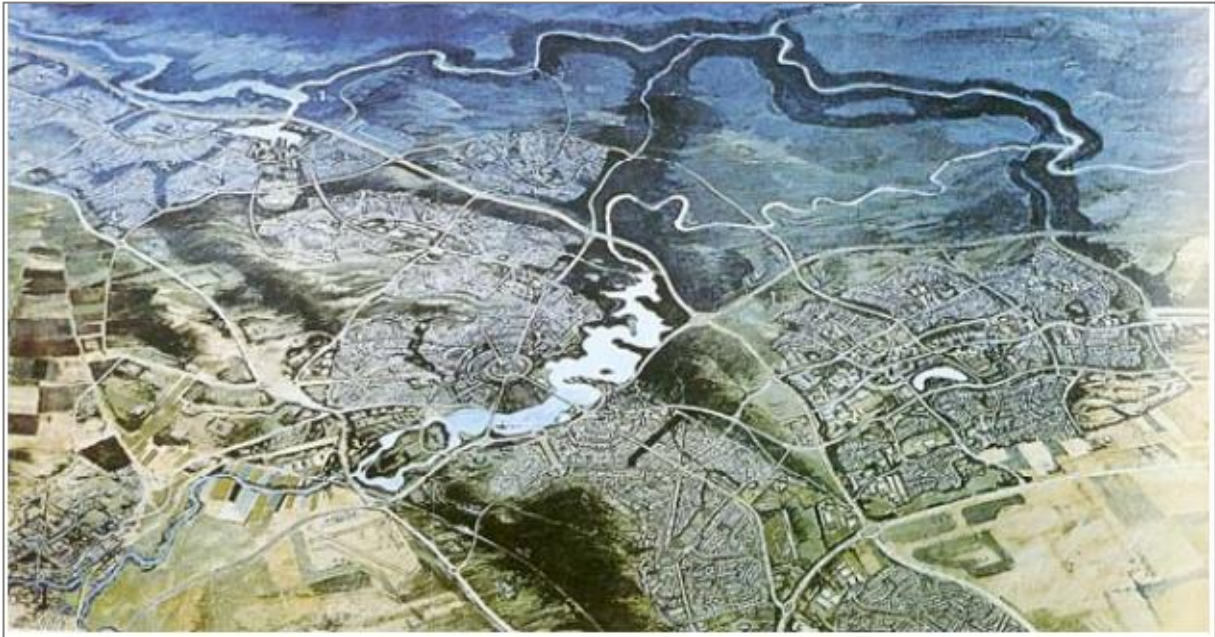
**Figure 43: Artist's impression of the NDC's Y Plan showing Belconnen to the West**
